Cardinal Home Inspection

# Inspection Report

12345 Somewhere Drive  
Anytown Va 56789

**Mark Burnett Va #3380-000538  
Washington, Va.  
540-675-3873**

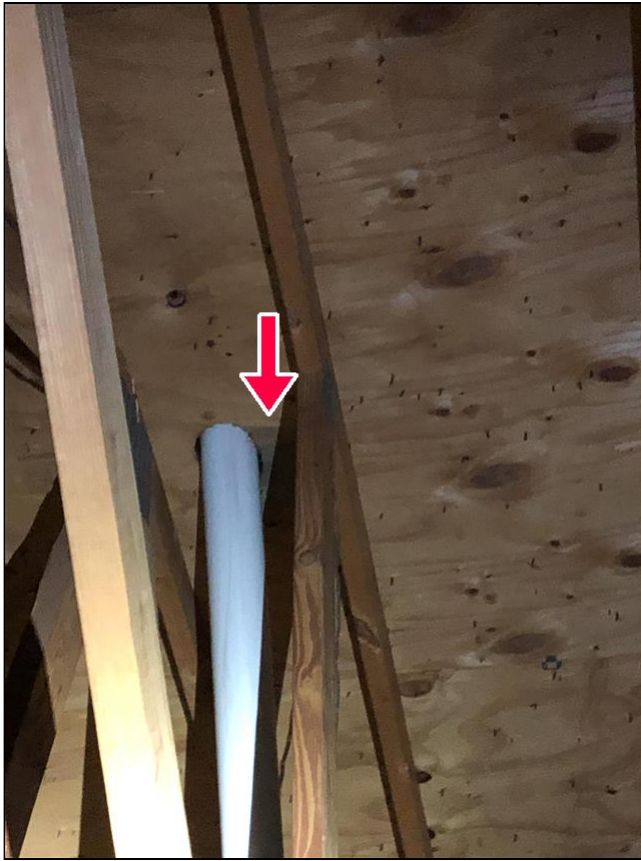
Moisture staining was observed at the underside of the roof sheathing around the rear vent stack. This normally indicates the vent boot flashing is leaking. Recommend a licensed roofer evaluate the vent boot flashing and determine if it is in need of replacement.

Moisture staining around vent stack

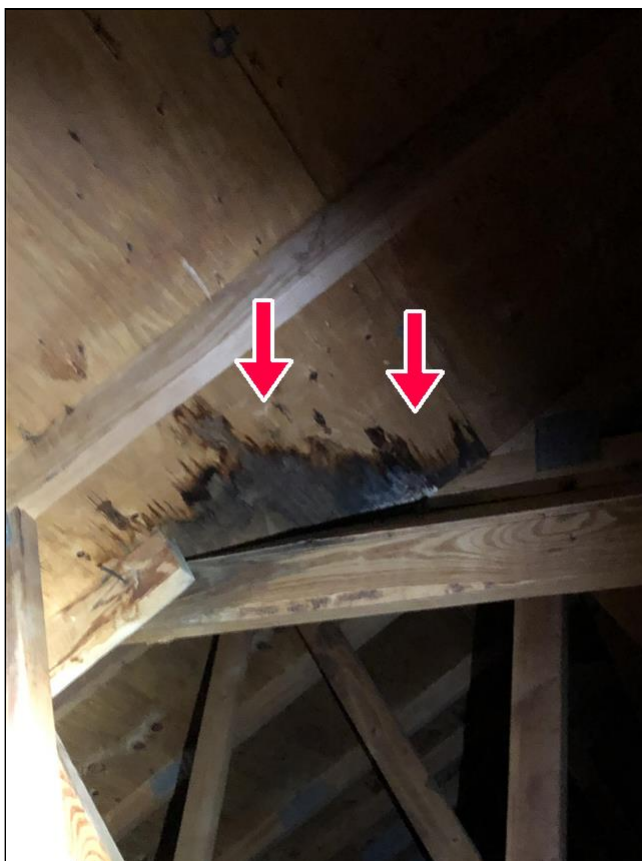
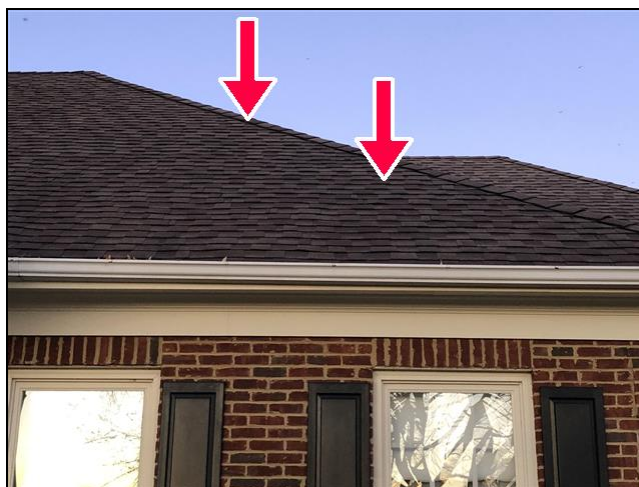
(1) A large moisture stain was observed at the underside of the roof sheathing. This can be seen from the attic access scuttle. Its cause could not be conclusively determined. Recommend a licensed roofer evaluate, determine cause and repair as deemed necessary.

Have roofer evaluate the entire underside of the roof sheathing for possible leaks. The attic was viewed from the ceiling scuttle. Due to insulation covering the ceiling joists, safe traversing/walking of the attic space was not possible. Evaluation of the attic was limited to viewing a small portion of the attic space from the ceiling scuttle.

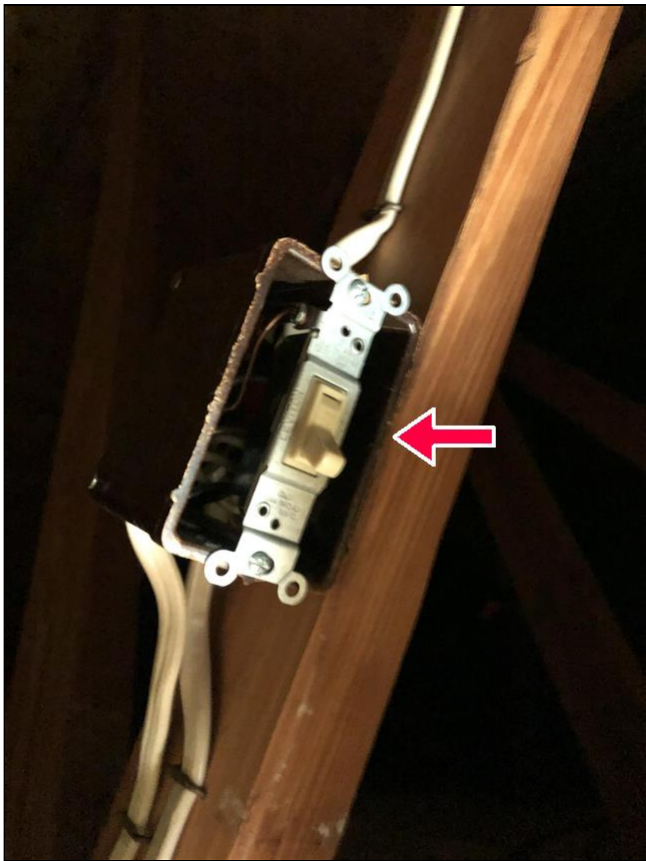
A cover plate is missing at the attic light switch. This is located inside the attic scuttle. A licensed electrician should install a cover onto the light switch.

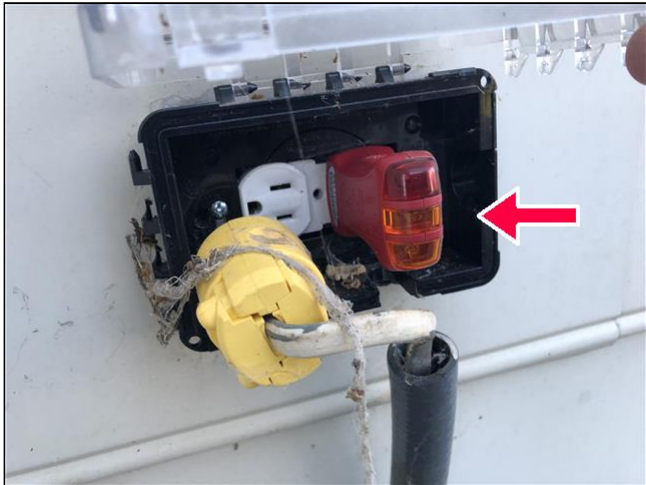
Rear deck receptacle

There are two exterior receptacles that were not energized/working when tested. Its speculated these are GFCI-protected receptacles. A reset could not be located/ found for the receptacles. Recommend a licensed electrician confirm the receptacles are GFCI-protected, and, in turn, locate a reset for them.

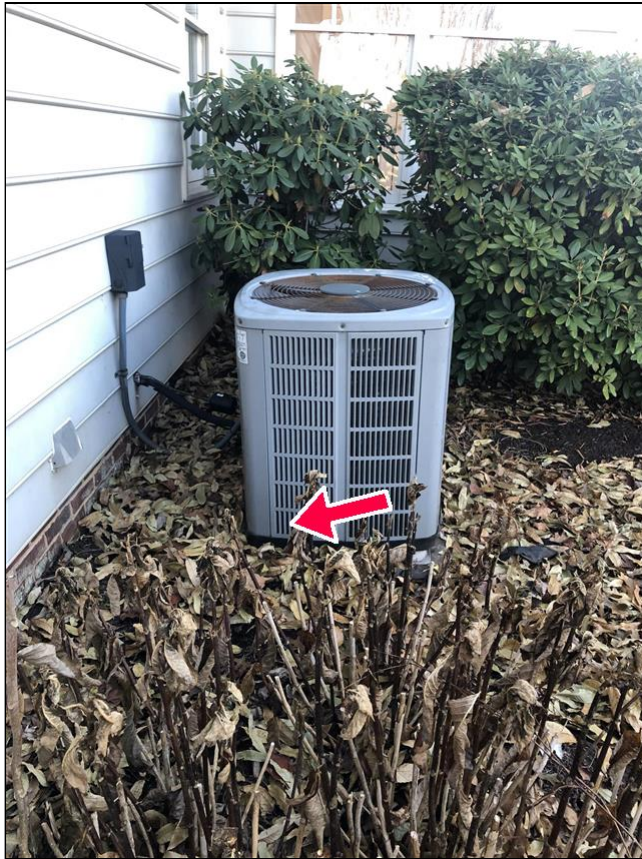
Condenser is out of level

- Properly leveling the condenser.
- Replace the damaged/torn insulation that covers the condenser's refrigerant lines.
- Reattach a cover plate at the front side of the air handler.

Service should be performed by a licensed HVAC technician.

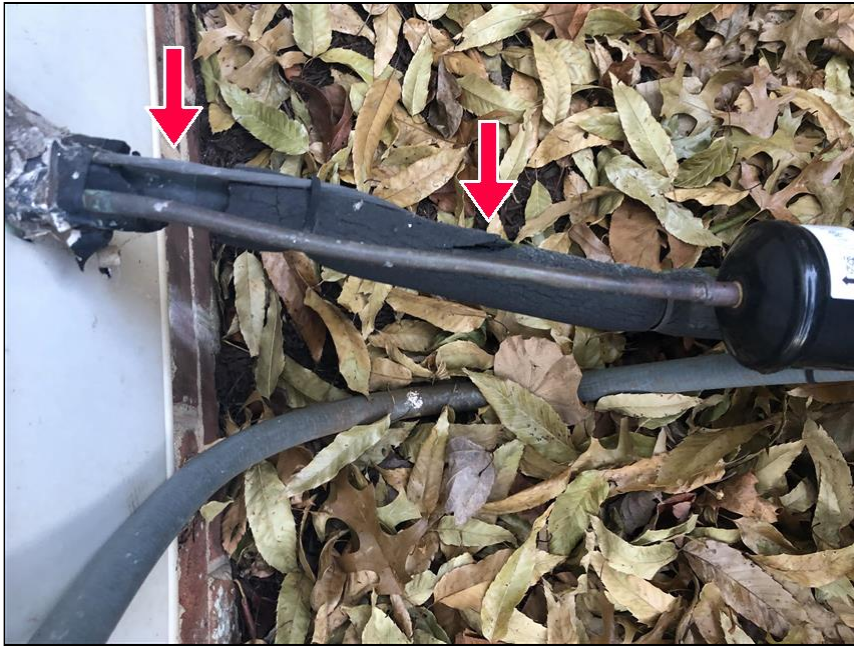
Insulation is damaged/torn

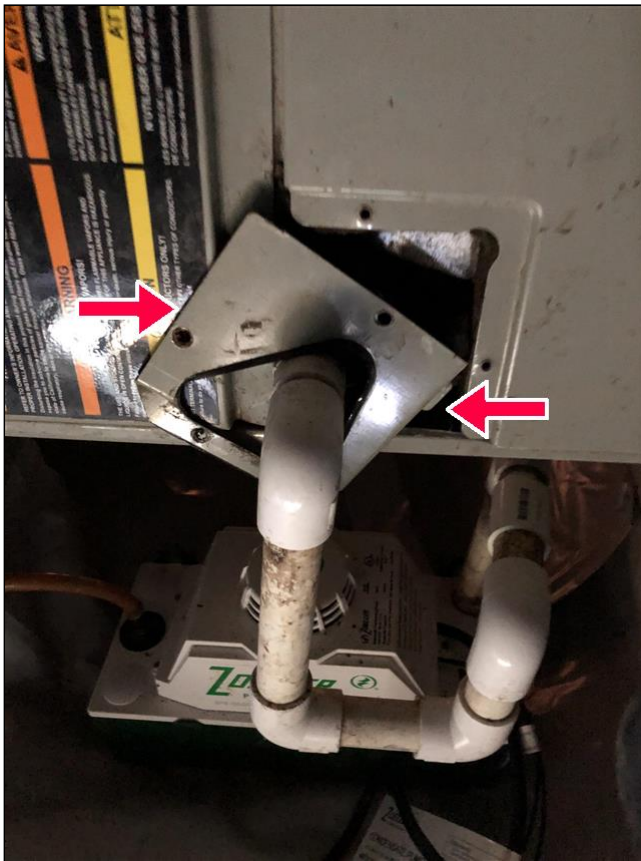
Cover plate loose at air handler

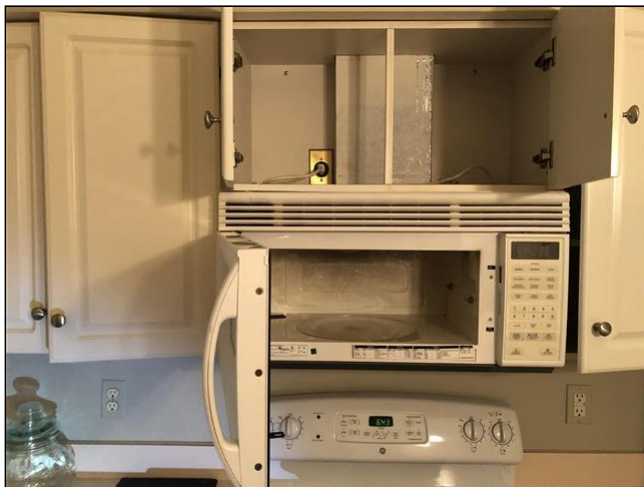
The built-in microwave was not operable when tested. It appears the microwave may be damaged or defective beyond repair. Replacement of the microwave is recommended.

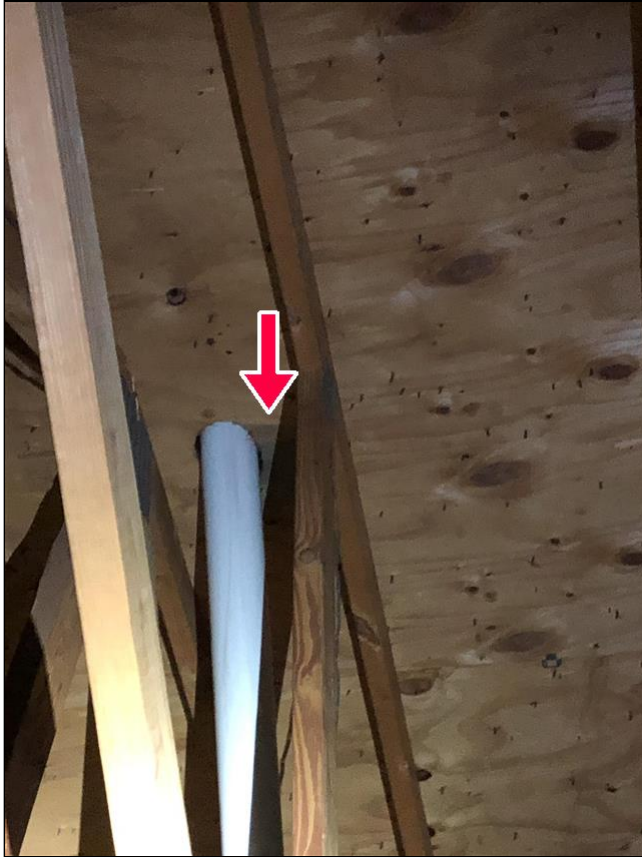
Moisture staining was observed at the underside of the roof sheathing around the rear vent stack. This normally indicates the vent boot flashing is leaking. Recommend a licensed roofer evaluate the vent boot flashing and determine if it is in need of replacement.

Moisture staining around vent stack

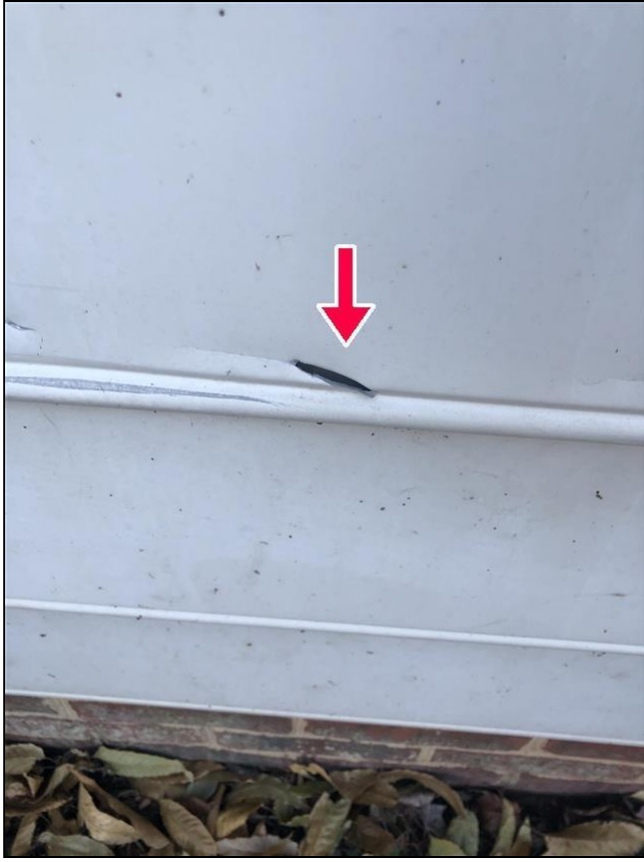
(2) Minor siding damage was noted at the rear of the home (adjacent to the HVAC condenser). This is a small cut in the siding. I recommend applying a small bead of exterior caulk to the affected area. This will prevent moisture from getting behind the siding.

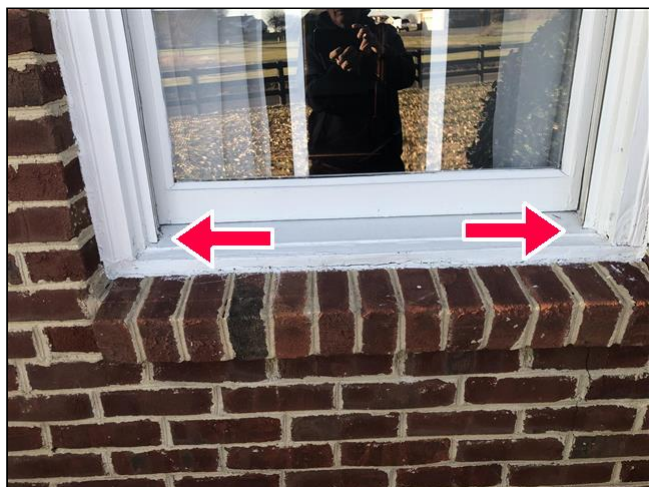
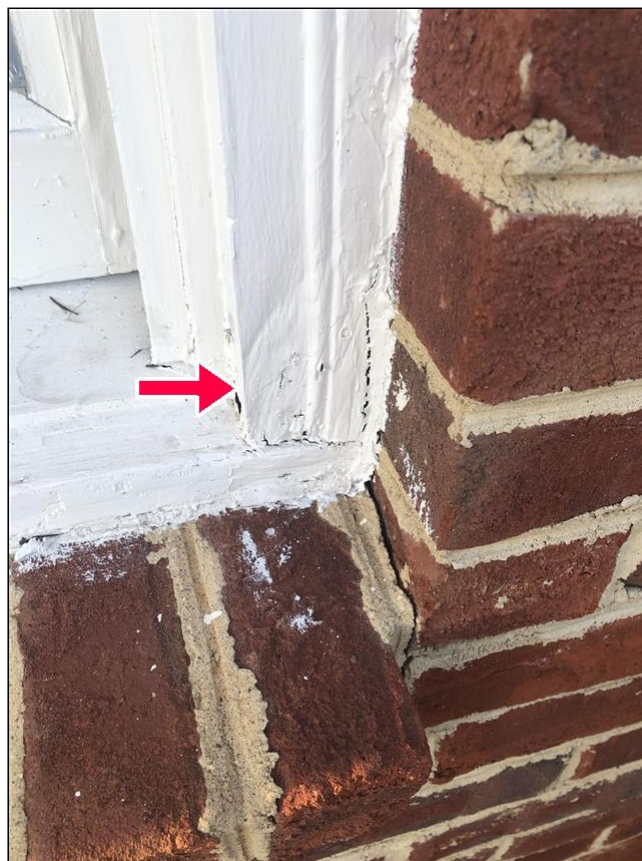
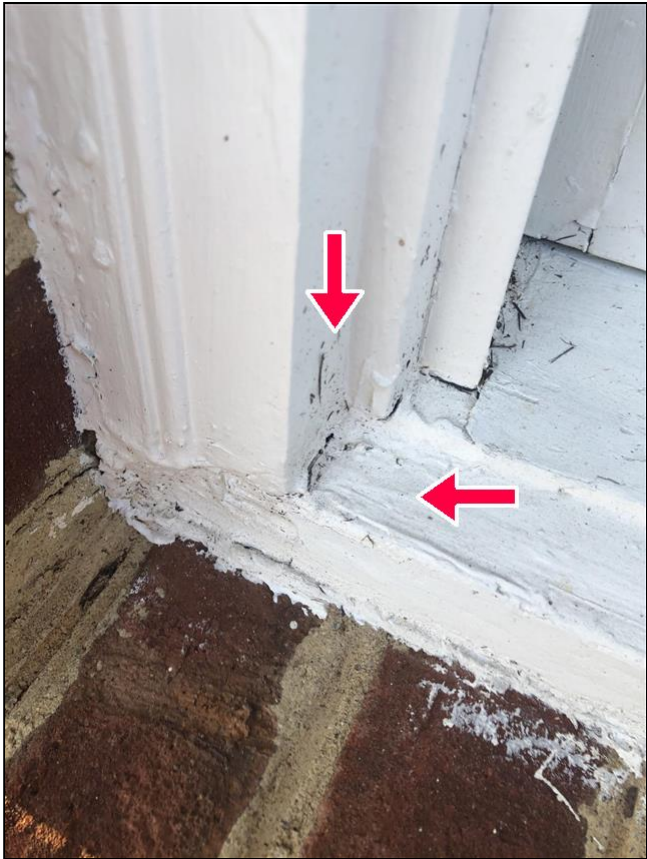
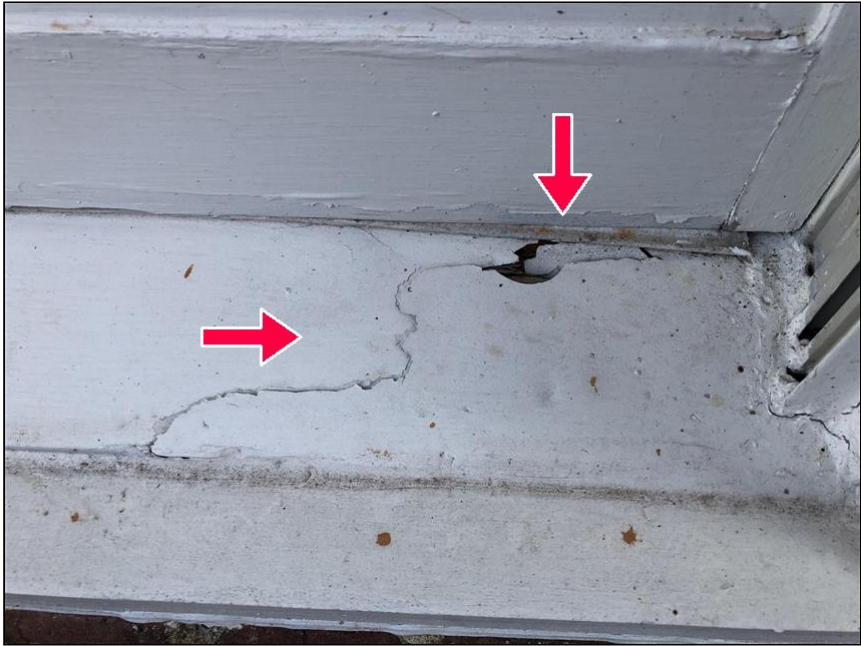
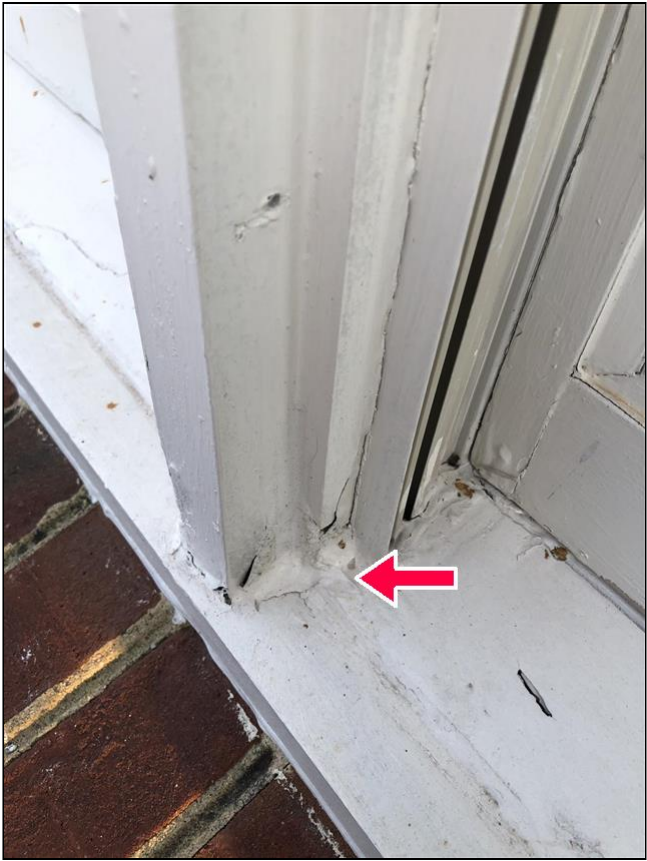
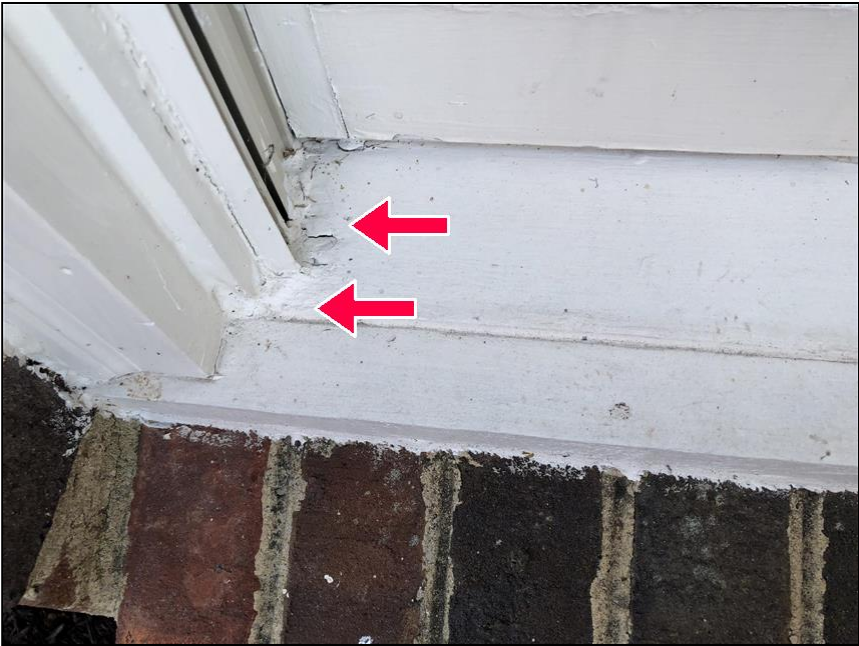
Signs of minor rot/decay were observed at most of the window trim/sills around the perimeter of the home. This is old/past damage that has been repaired. Repairs consisted of applying caulk and/or wood filler to the affected areas. Some of the repaired areas were slightly soft/spongy. I recommend monitoring the trim and sills. You may want a handyman evaluate and determine if the past repairs can be improved.

Appears many of the windows/windowsills were not properly prepped before the finished paint coat was applied. Its speculated the windows/windowsills were not primed before painting. The paint finish is chipped/flaky. You may want a handyman/painter to properly prep and paint these windows. These windows were located at the rear deck and front of home.

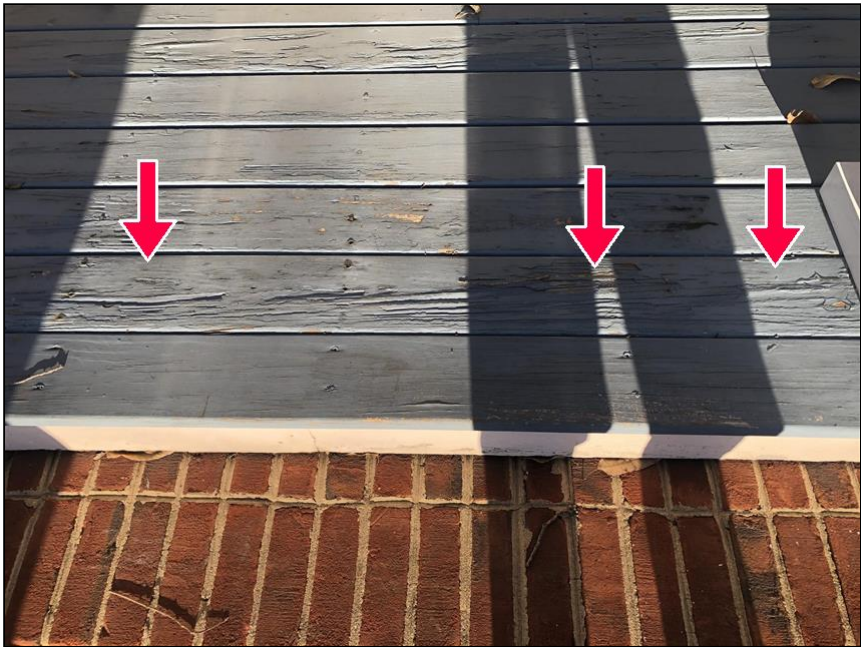
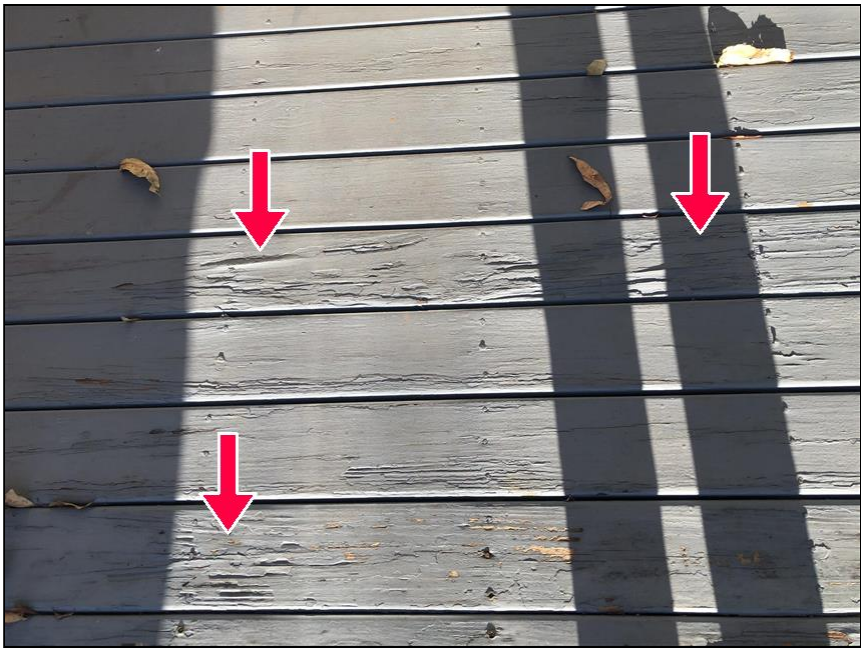
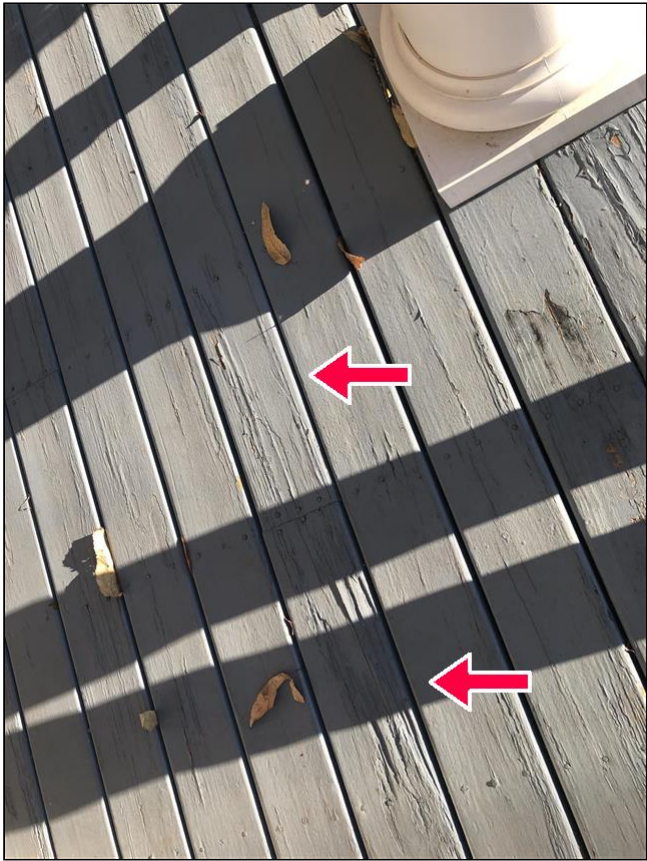
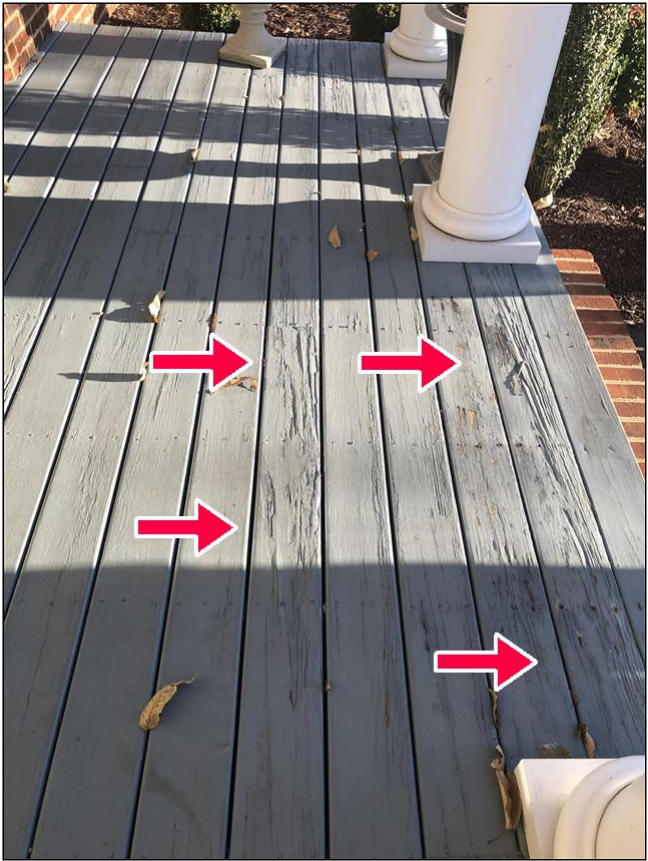
Some of the floor boards at the front porch are showing signs of early deterioration. The boards are still structurally sound. I recommend these be monitored. Budget to replace in the next 1-2 years (approx) .

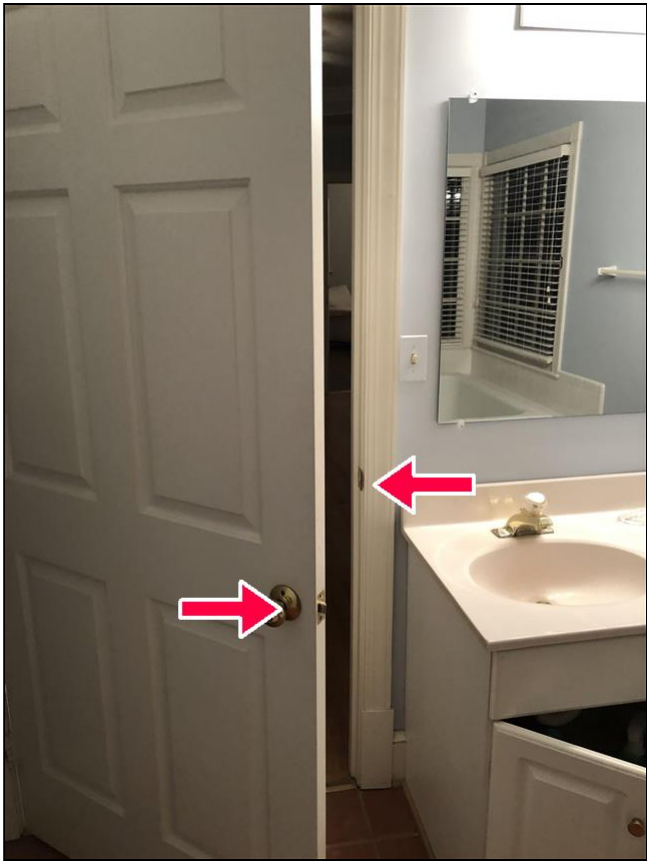
Master bathroom door

There are a few doors that need their strike plate adjusted so they will latch properly. These were located in the master bathroom and dining room.

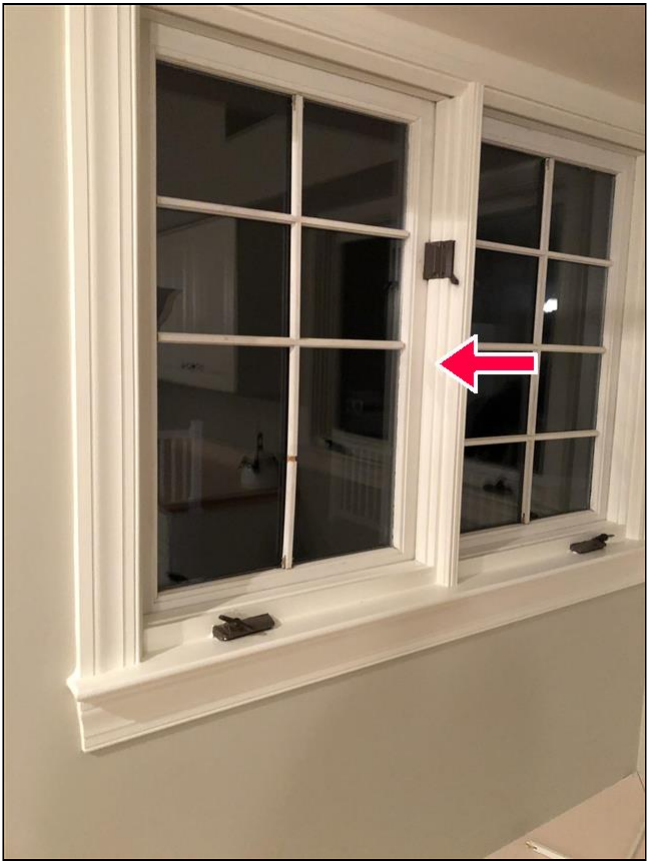
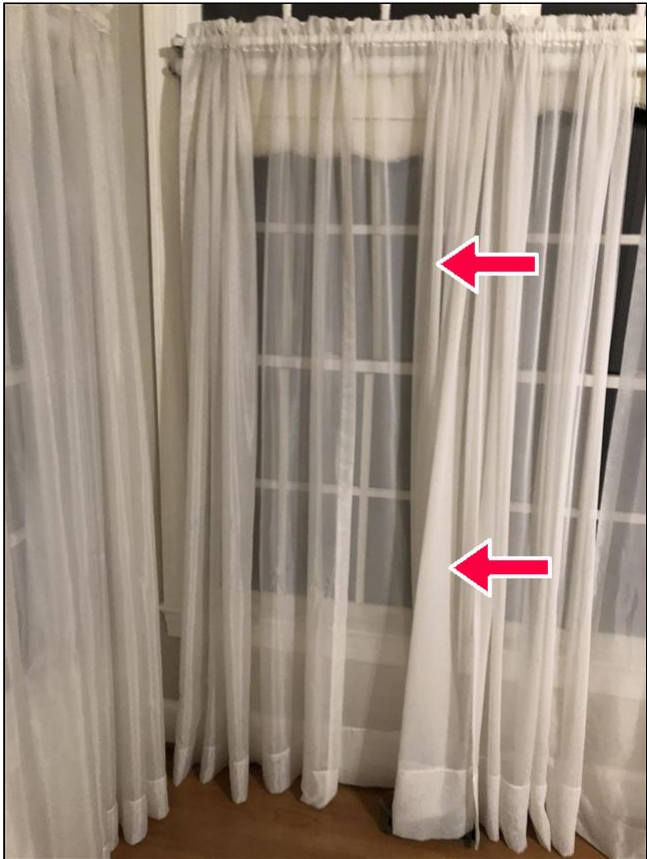
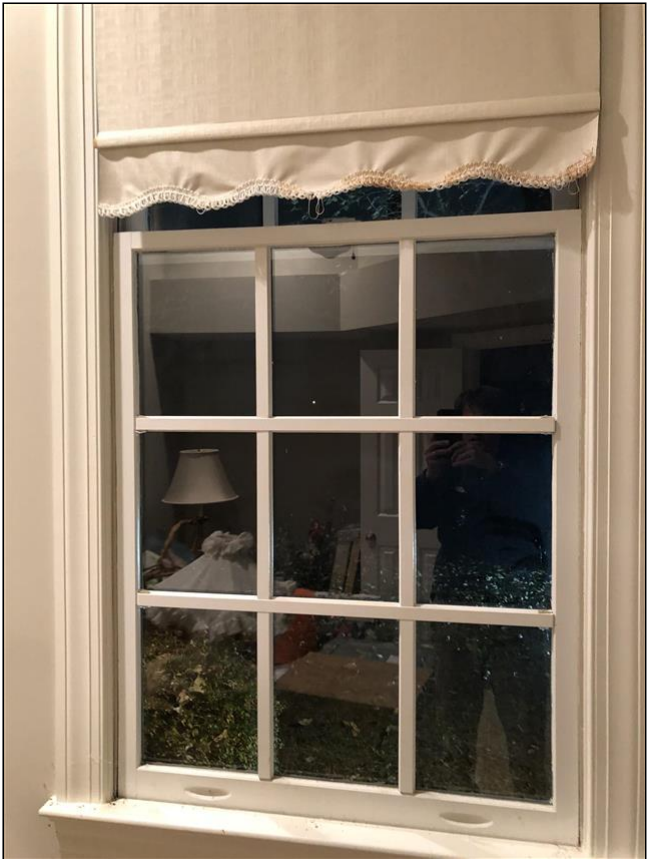
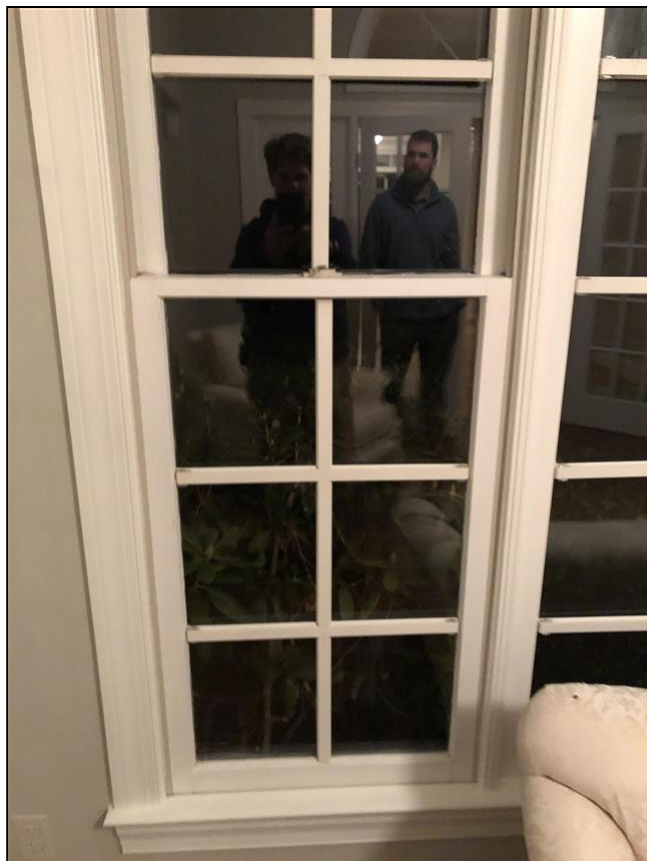
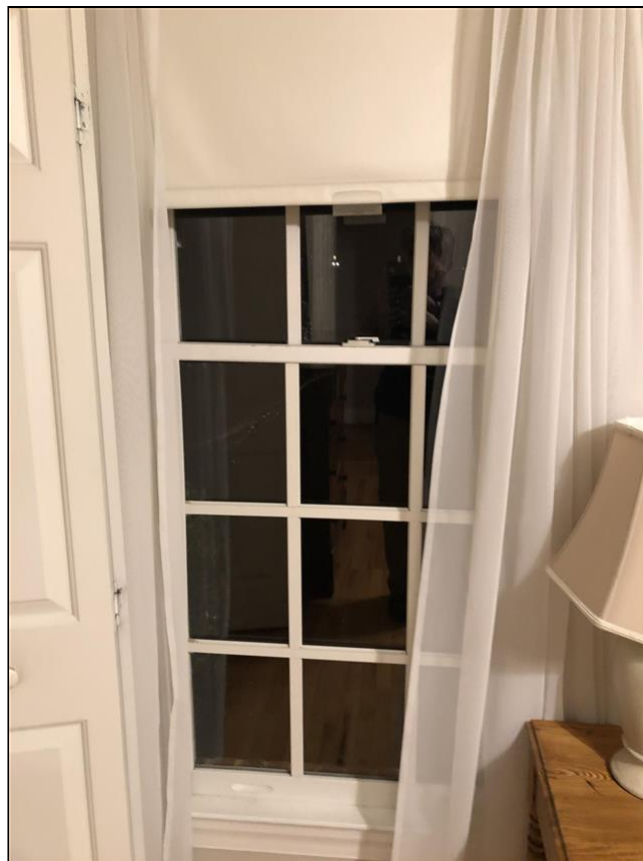
(1) There were several windows that would not open when tested. These windows appeared to be painted shut. These can generally be opened by running a putty knife between the window and window track.

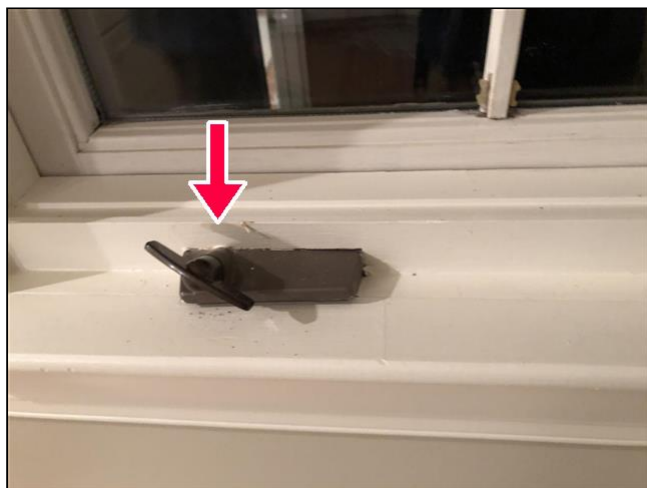
(2) The window operator at the kitchen window (1st from left) appears to be stripped. When opening/closing the window, the operator spins and will not effectively open/close the window. This should be available at most hardware stores.

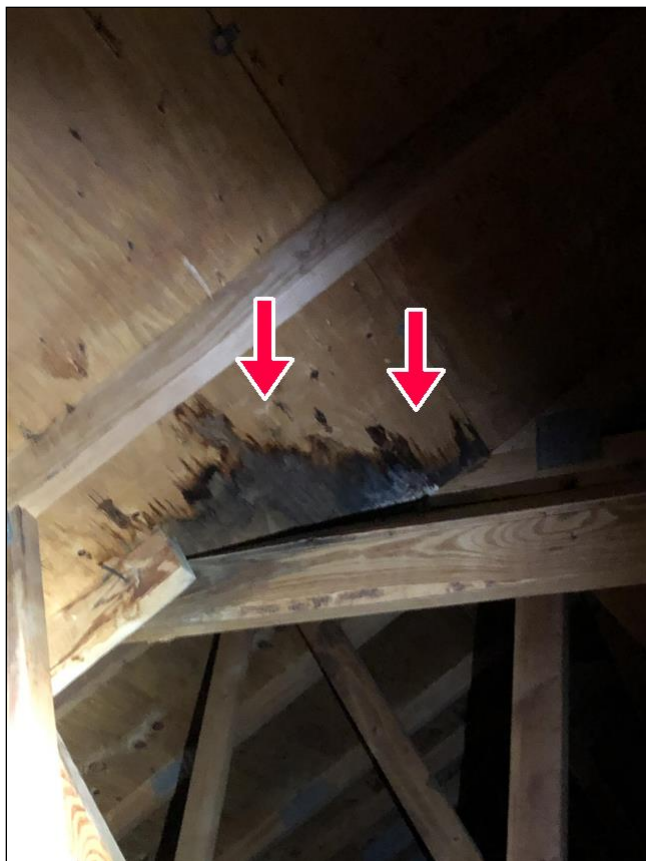
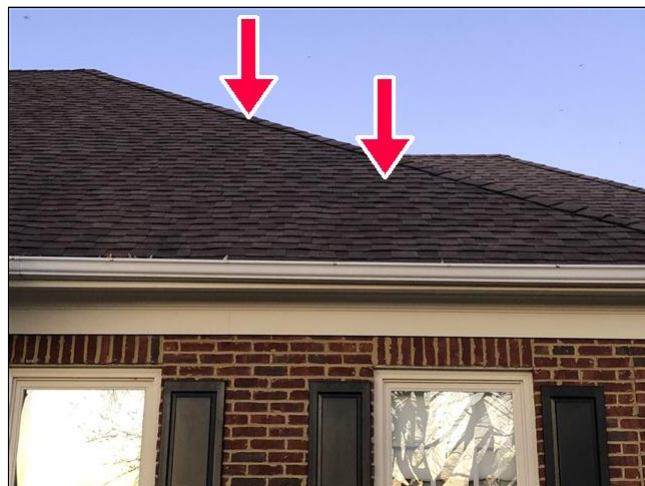
(1) A large moisture stain was observed at the underside of the roof sheathing. This can be seen from the attic access scuttle. Its cause could not be conclusively determined. Recommend a licensed roofer evaluate, determine cause and repair as deemed necessary.

Have roofer evaluate the entire underside of the roof sheathing for possible leaks. The attic was viewed from the ceiling scuttle. Due to insulation covering the ceiling joists, safe traversing/walking of the attic space was not possible. Evaluation of the attic was limited to viewing a small portion of the attic space from the ceiling scuttle.

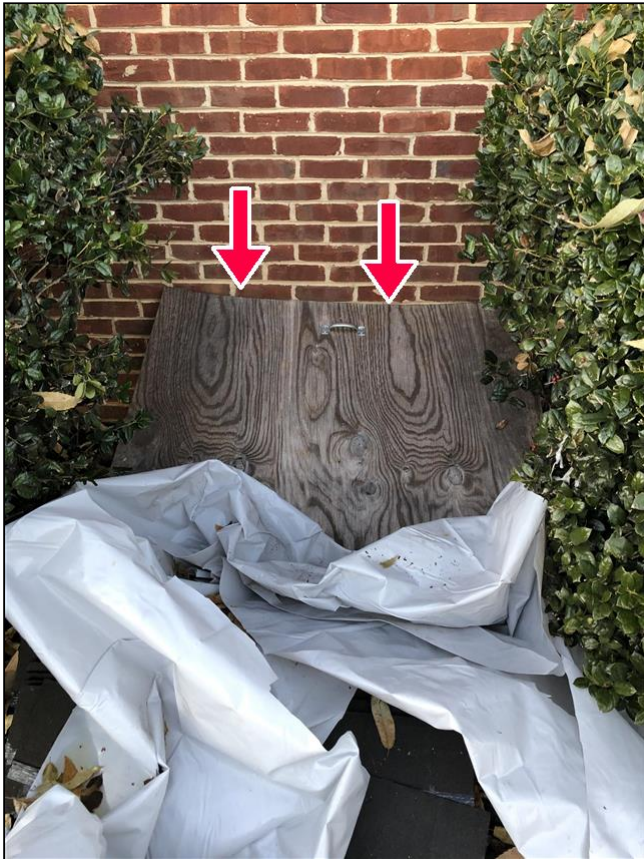
Access Cover

Its recommended to consider replacing the crawlspace cover. This is constructed of substandard material. A more robust cover that completely covers the crawlspace access well is recommended. This will prevent water/vermin/snakes from entering the access well.

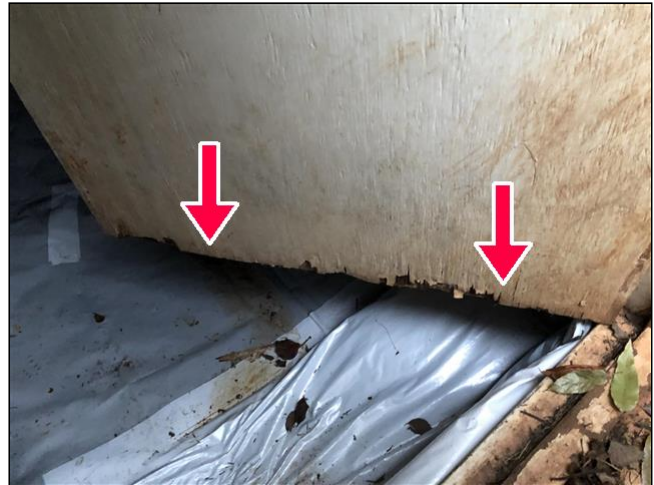
Crawlspace Door

Its recommended to consider replacing the crawlspace door. This is constructed of substandard material. The door is beginning to deteriorate/decay along its bottom. A more robust door is recommended.

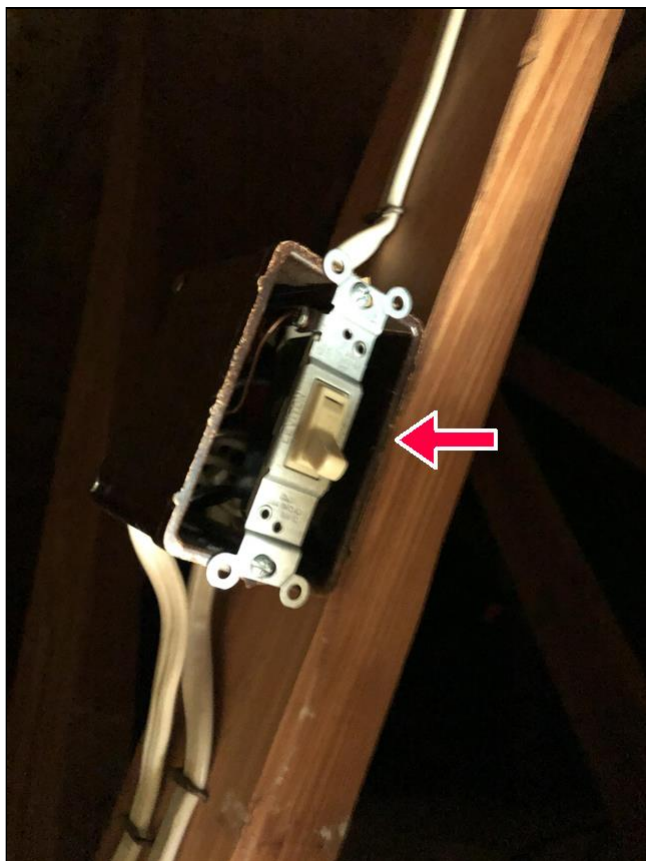
A cover plate is missing at the attic light switch. This is located inside the attic scuttle. A licensed electrician should install a cover onto the light switch.

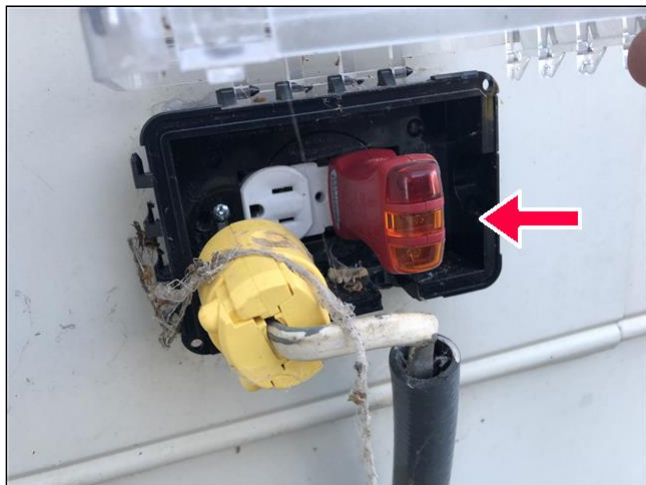
Rear deck receptacle

There are two exterior receptacles that were not energized/working when tested. Its speculated these are GFCI-protected receptacles. A reset could not be located/found for the receptacles. Recommend a licensed electrician confirm the receptacles are GFCI-protected, and, in turn, locate a reset for them.

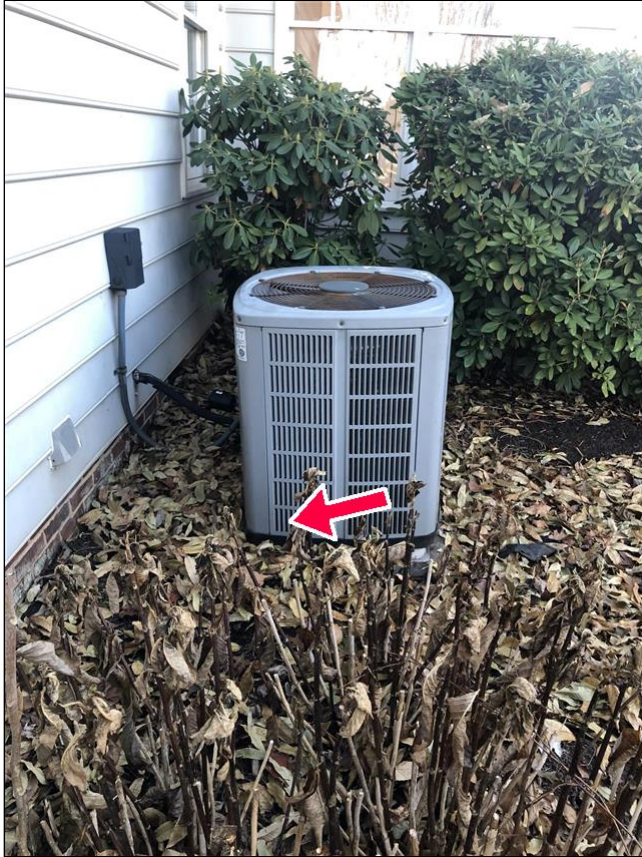
Condenser is out of level

Service should be performed by a licensed HVAC technician.

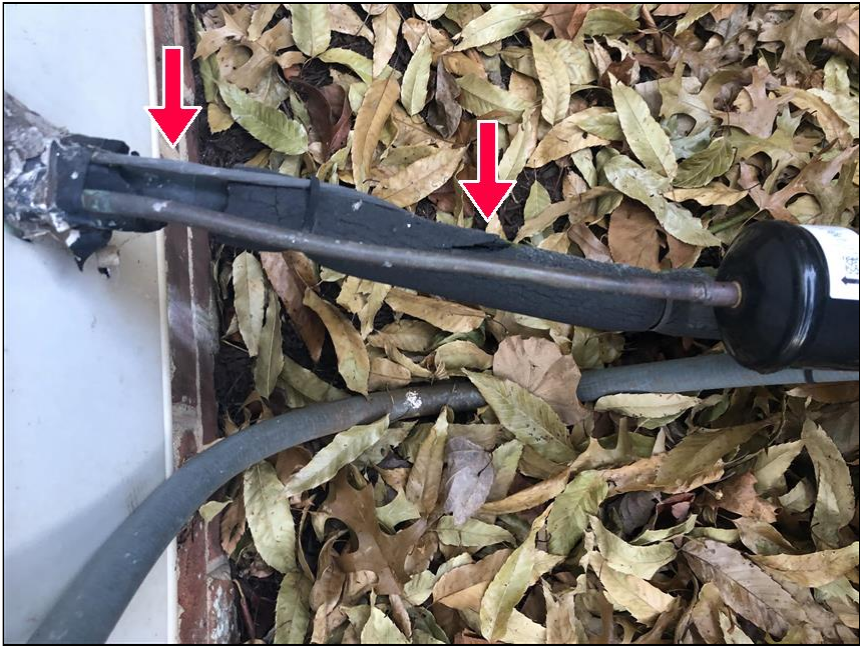
Insulation is damaged/torn

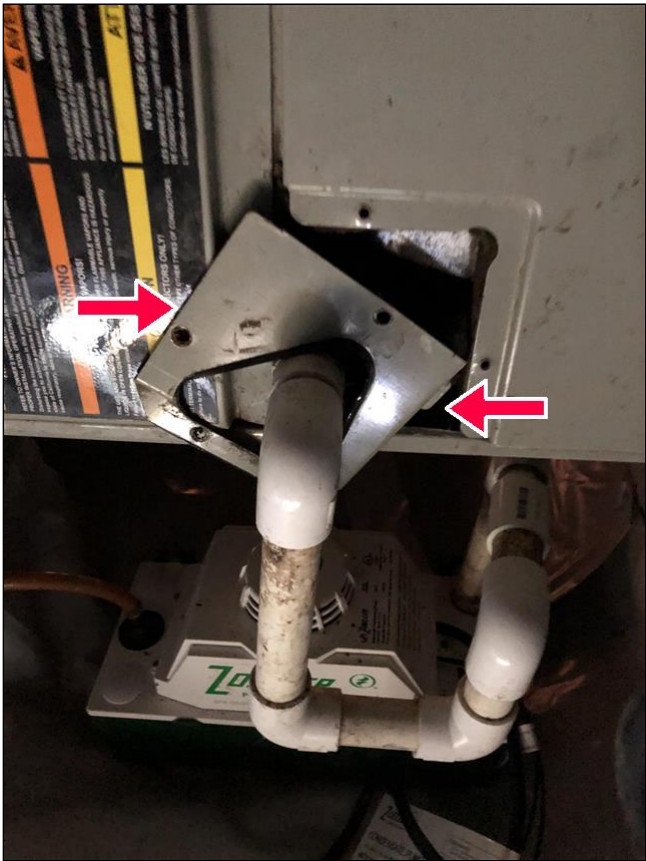
Cover plate loose at air handler

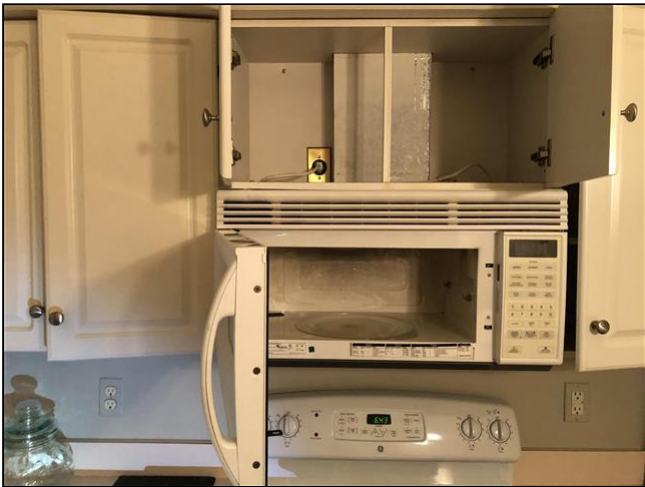
The built-in microwave was not operable when tested. It appears the microwave may be damaged or defective beyond repair. Replacement of the microwave is recommended.

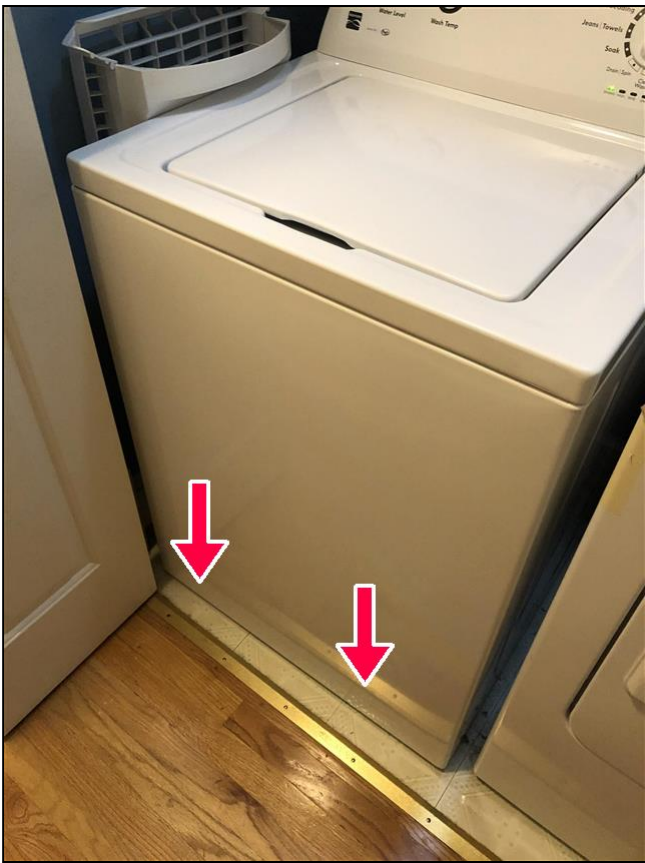
Recommend a drain/catch pan be installed under the washer. In the event of a leak, any water would be captured in the pan and exhausted to the exterior of the home.
