Cardinal Home Inspection

# Inspection Report

12345 Somewhere Drive  
Anytown Va 56789

**Mark Burnett Va #3380-000538  
Washington, Va.  
540-675-3873**

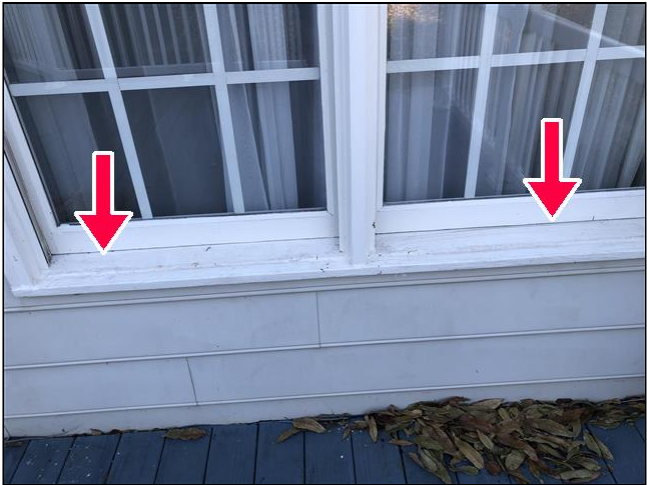
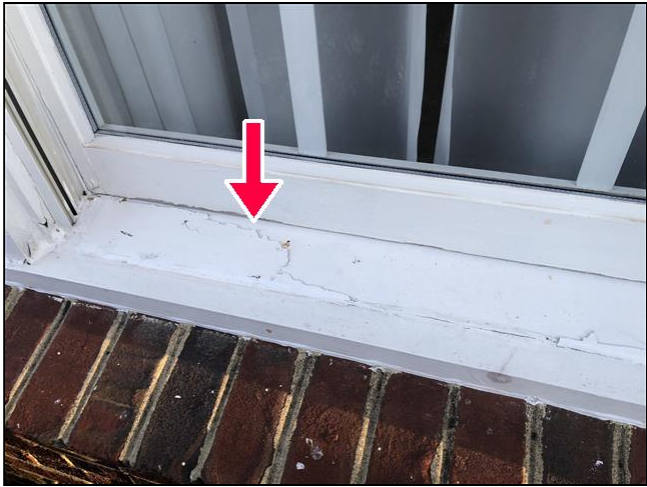
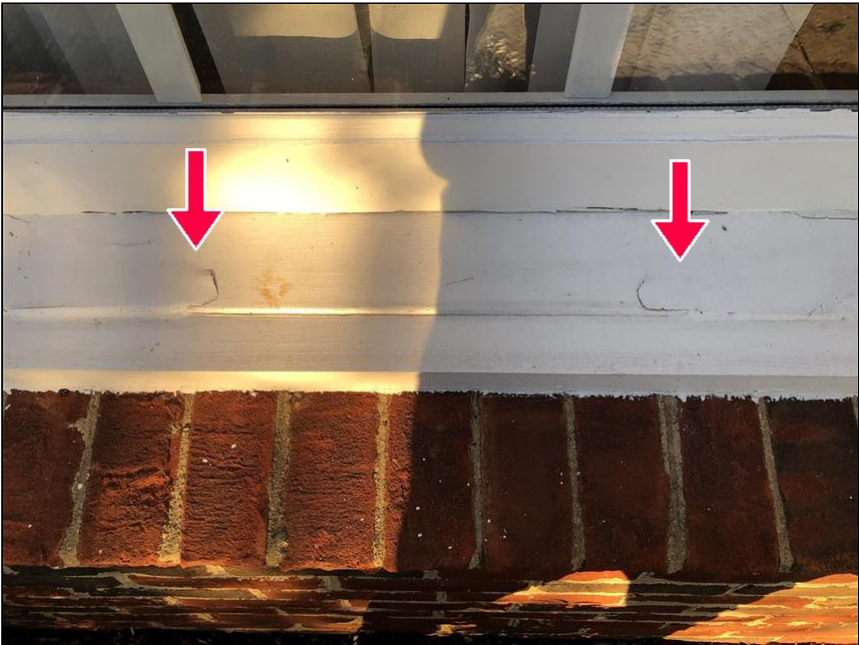
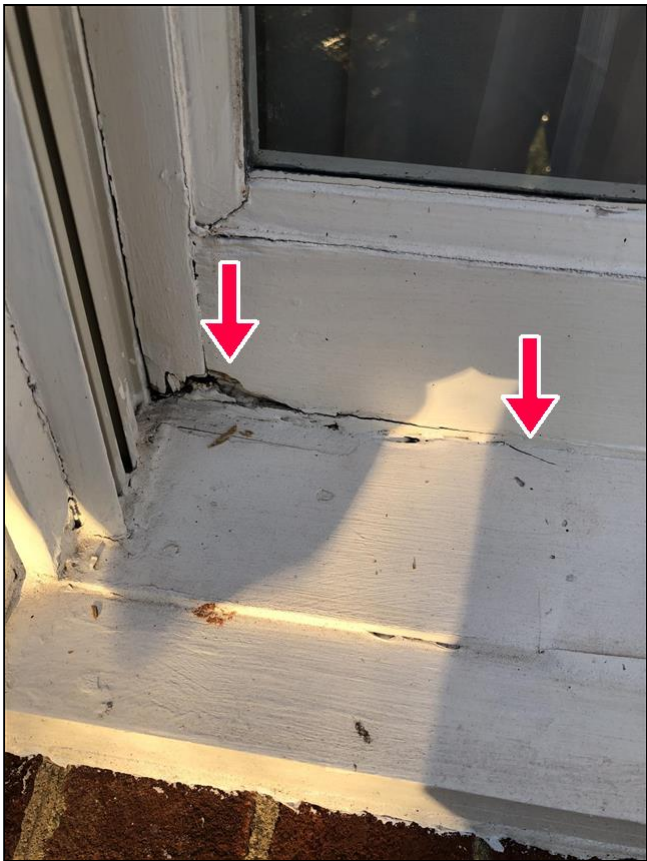
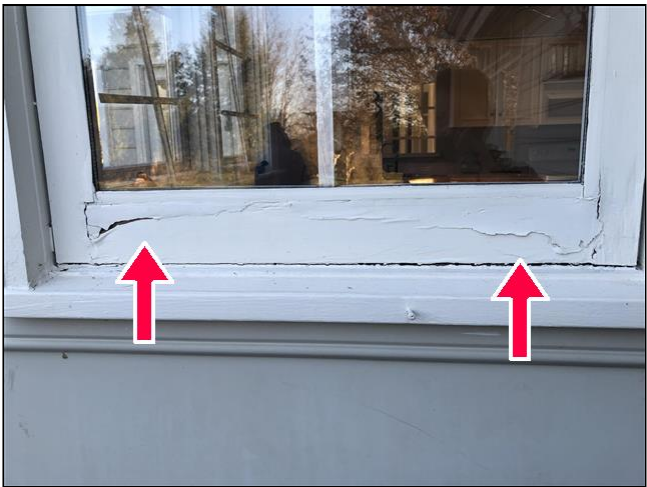
Appears many of the windows/windowsills were not properly prepped before the finished paint coat was applied. Its speculated the windows/windowsills were not primed before painting. The paint finish is chipped/flaky. You may want a handyman/painter to properly prep and paint these windows. These windows were located at the rear deck and front of home.

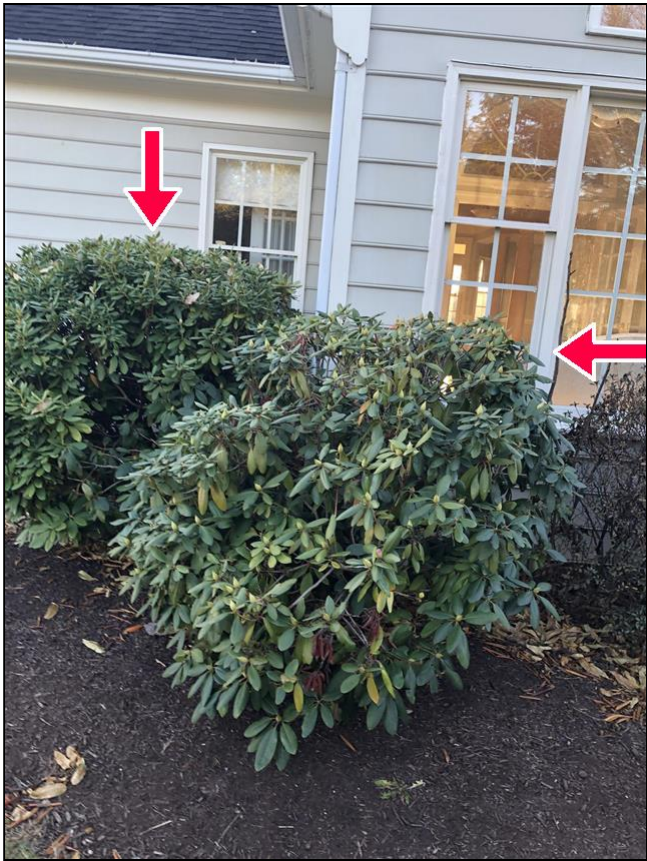
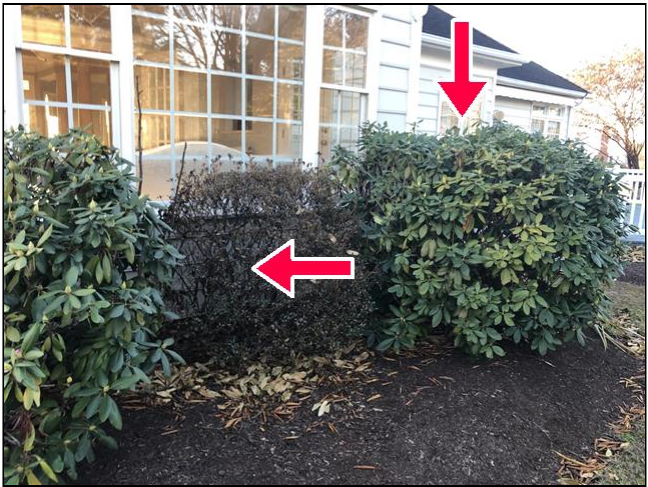
(1) FYI: Vegetation growing near exterior walls should be kept trimmed away from the siding, window trim, and eaves to reduce the risk of insect and/or water damage.

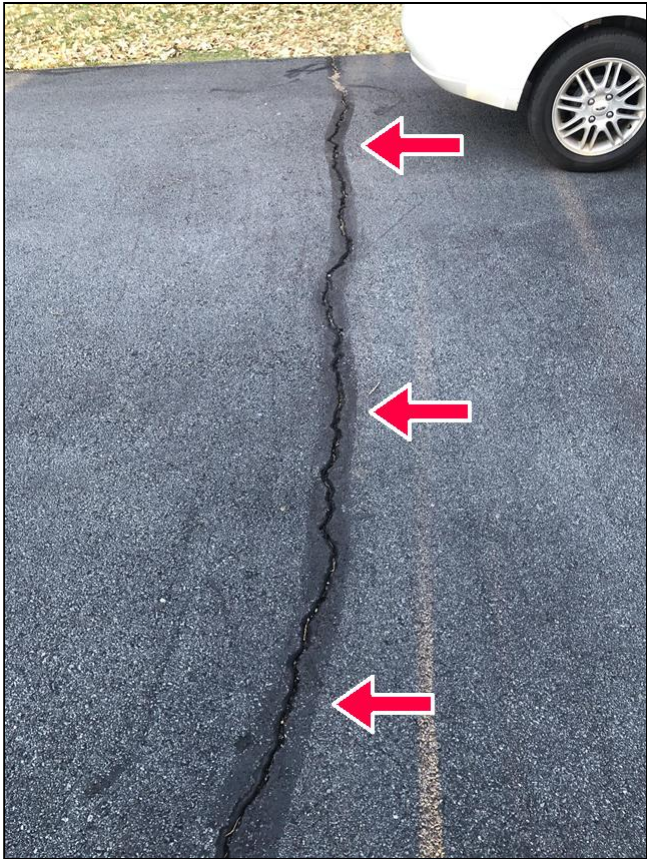
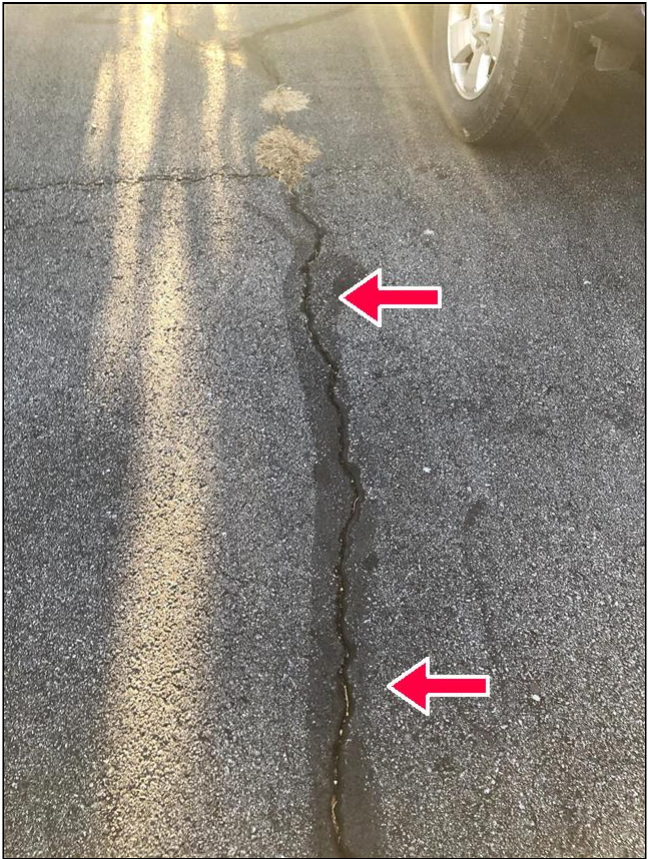
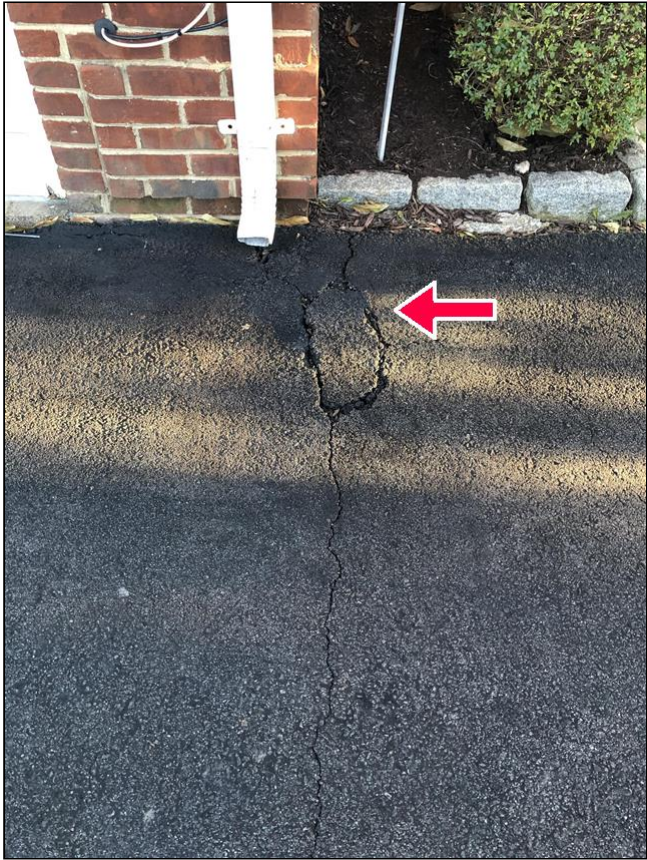
(2) The asphalt driveway will need periodic maintenance. This includes resurfacing/sealing the driveway every 5-6 years to maintain its appearance and protect it from cracks and oil damage. **The current cracks will be filled/covered by the resurfacing/sealing process.**

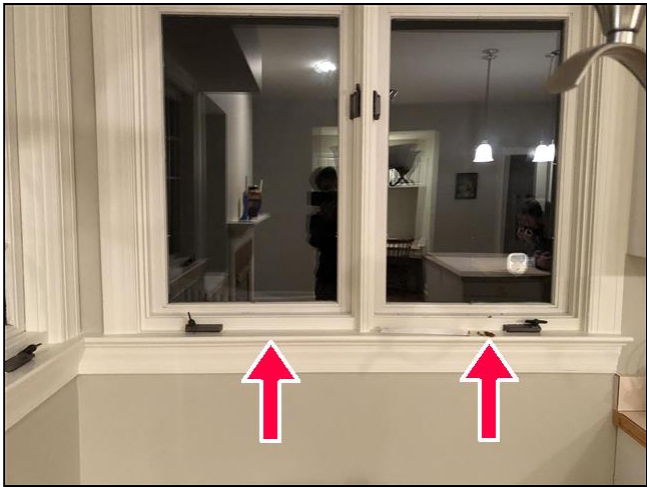
(1) There were several windows that would not open when tested. These windows appeared to be painted shut. These can generally be opened by running a putty knife between the window and window track.

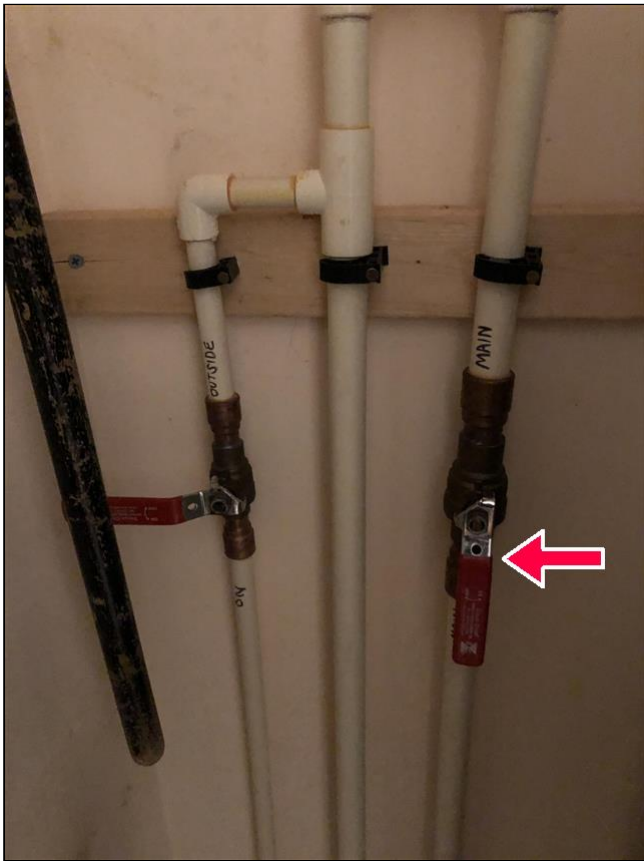
The main water shutoff valve is located in the water heater closet.

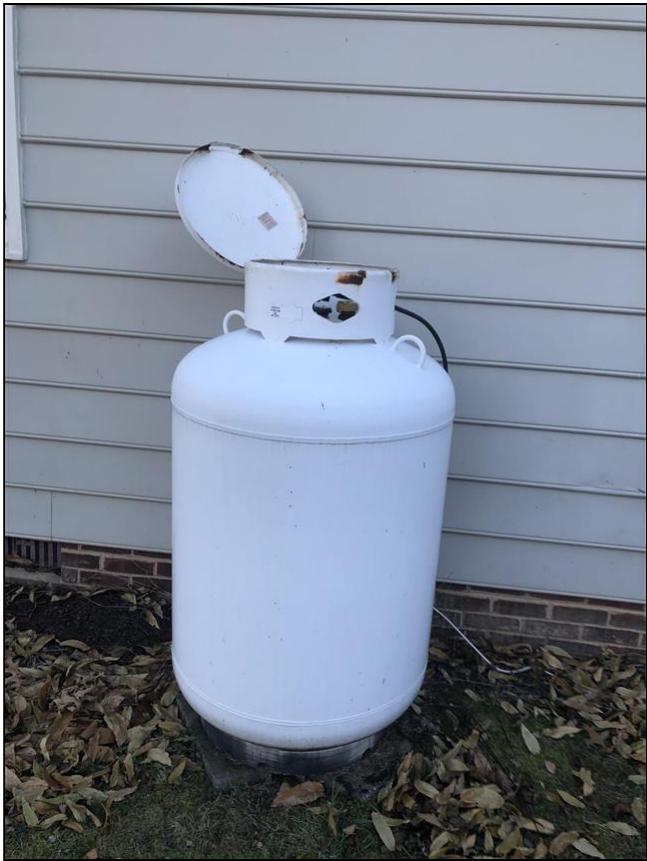
There is Liquid Propane (LP) gas tank installed at the rear of the home. This provides fuel to the fireplace. The fireplace is the only gas-fueled appliance in the home.

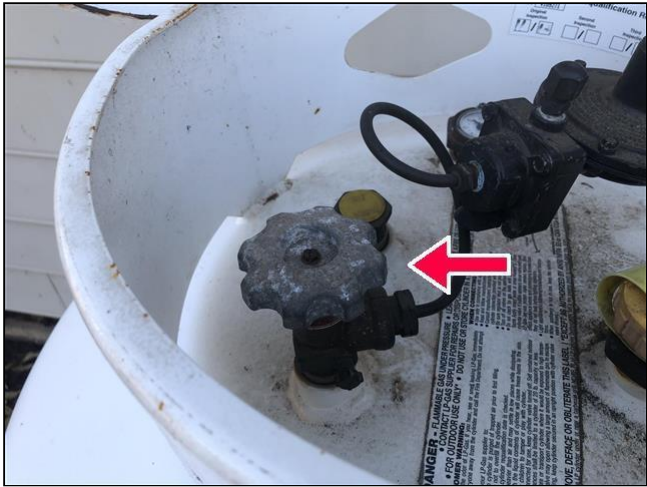
The main gas shutoff valve is located at the gas storage tank.

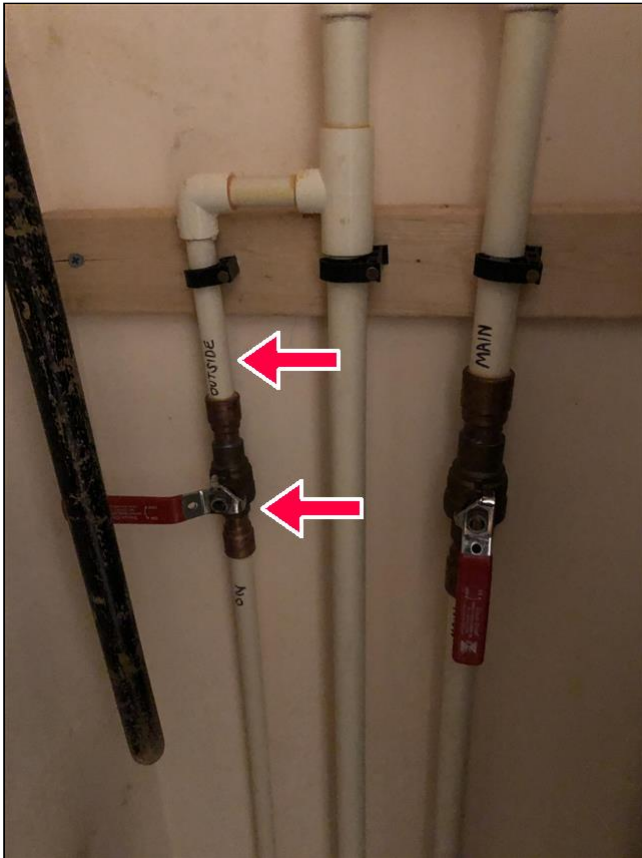
Hose bibs were located at the front and rear of the home. The hose bibs have been turned off for the winter.

FYI: The inside shutoff valve for the hose bibs is located in the water heater closet.

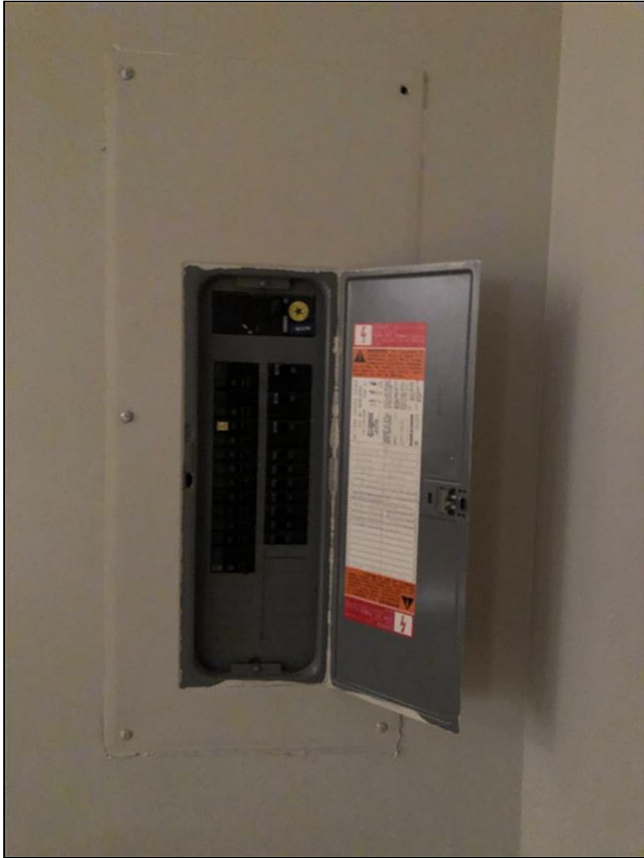
The electrical service panel is located in the converted garage area. The main electric disconnect is located at the service panel.

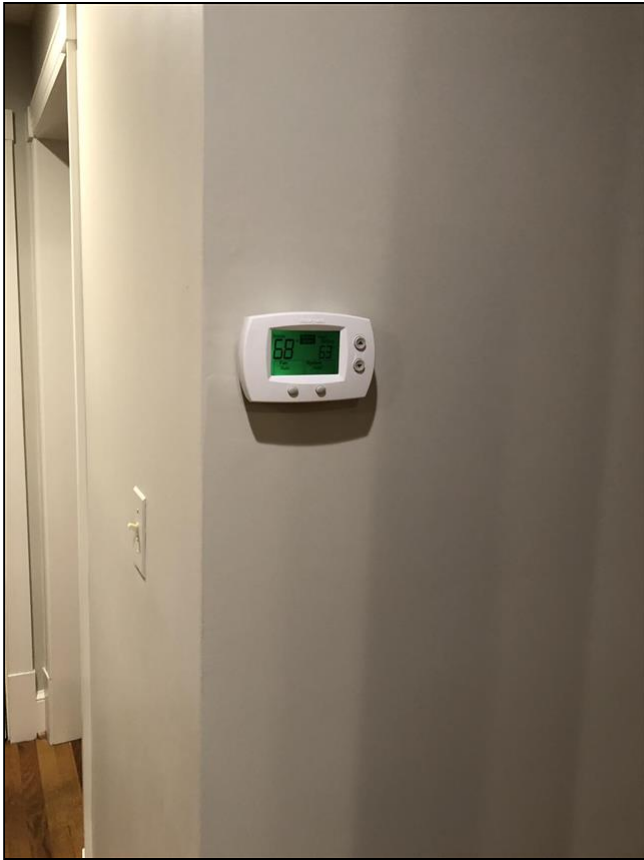
The thermostat is located in the main hallway. The thermostat was operable when tested.

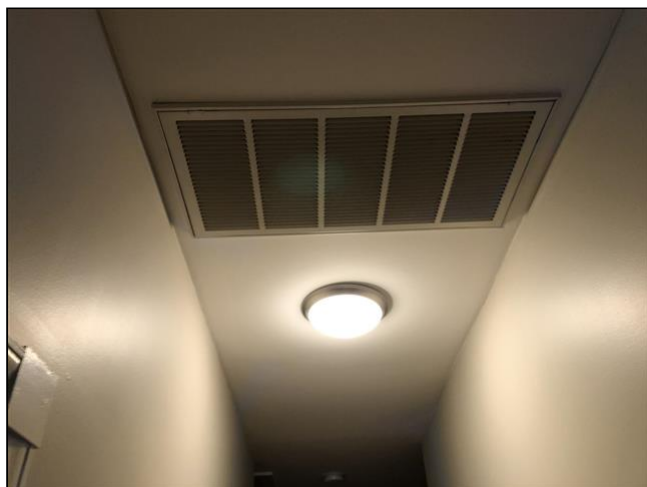
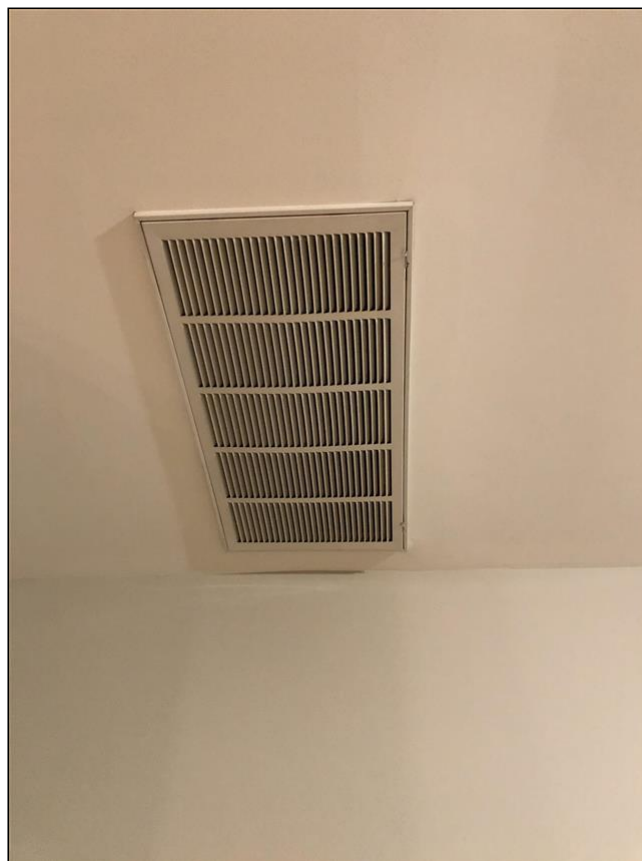
**Filter Location:** Main level hallway

**Filter Size:** 10x30x1"

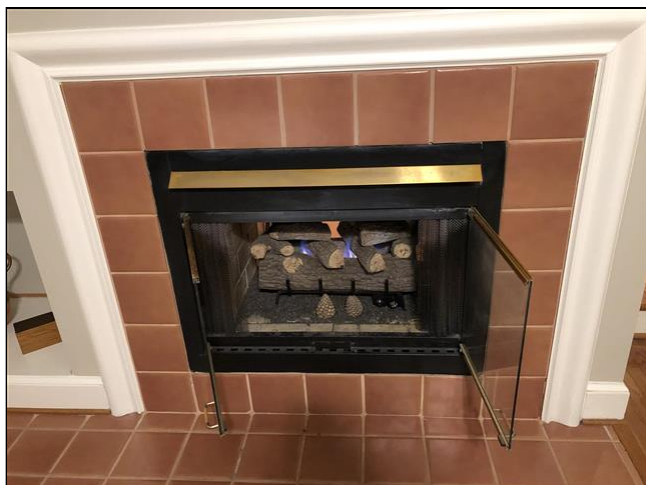
(1) The gas fireplace operated when tested. No deficiencies noted in regard to its operation.
